SALIENT DETAILS OF A RECENTLY COLLAPSED PARTLY- CONSTRUCTED PEDESTRIAN BRIDGE AT FLORIDA

Alok Bhowmick*,

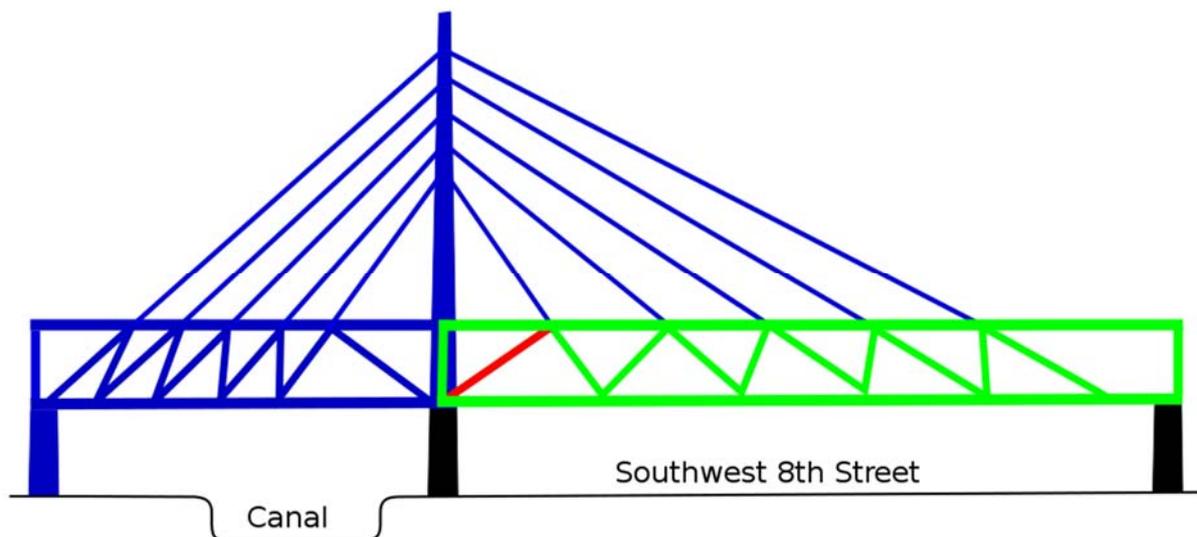
Fig. 3 : Schematic General Arrangement of the bridge.

The schematic arrangement of the 2 span structure and the status of construction at the time of collapse is given in Fig. 3 below.

- Green: indicates collapsed parts,*
- Blue: indicates not installed at the time of the collapse.*
- Red : Indicates the diagonal beam that was undergoing post-tension cable/rod adjustment at the time of the collapse.*

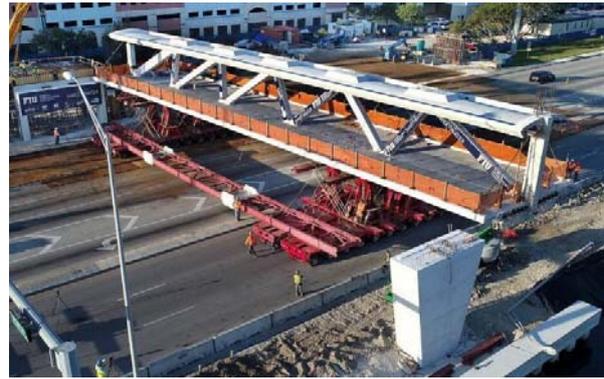
The 862-tonne, 174' (53m) pedestrian bridge had been newly erected on 10th March 2018, in just six hours. The span was positioned by rotating the entire precast span using SPMT transporter (Fig.4). 2 days before the collapse, the engineering company, FIGG Bridge Engineers reported about some cracks in the bridge structure at the north

Fig.4 Photograph of the span being positioned over support.

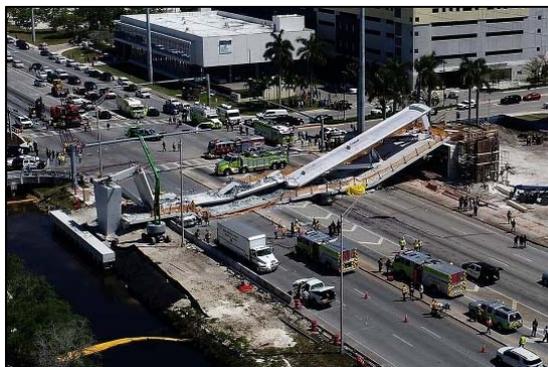
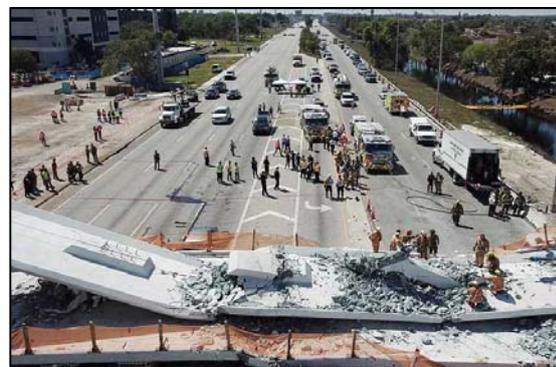
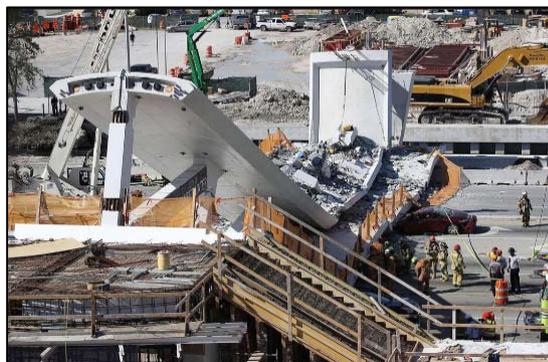
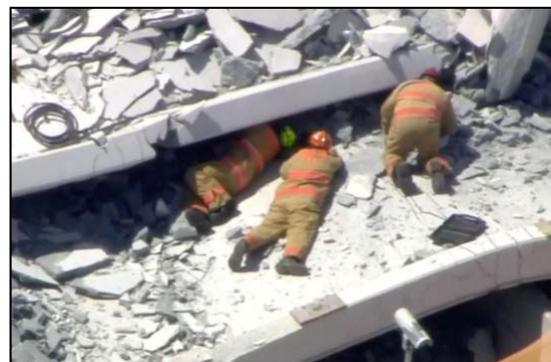
Fig. 5 shows some of the photographs of collapsed bridge.

Fig.5 Few Photographs of the collapsed bridge site
