LAYOUT OF ROOF SLAB & BEAMS OVER GROUND FLOOR

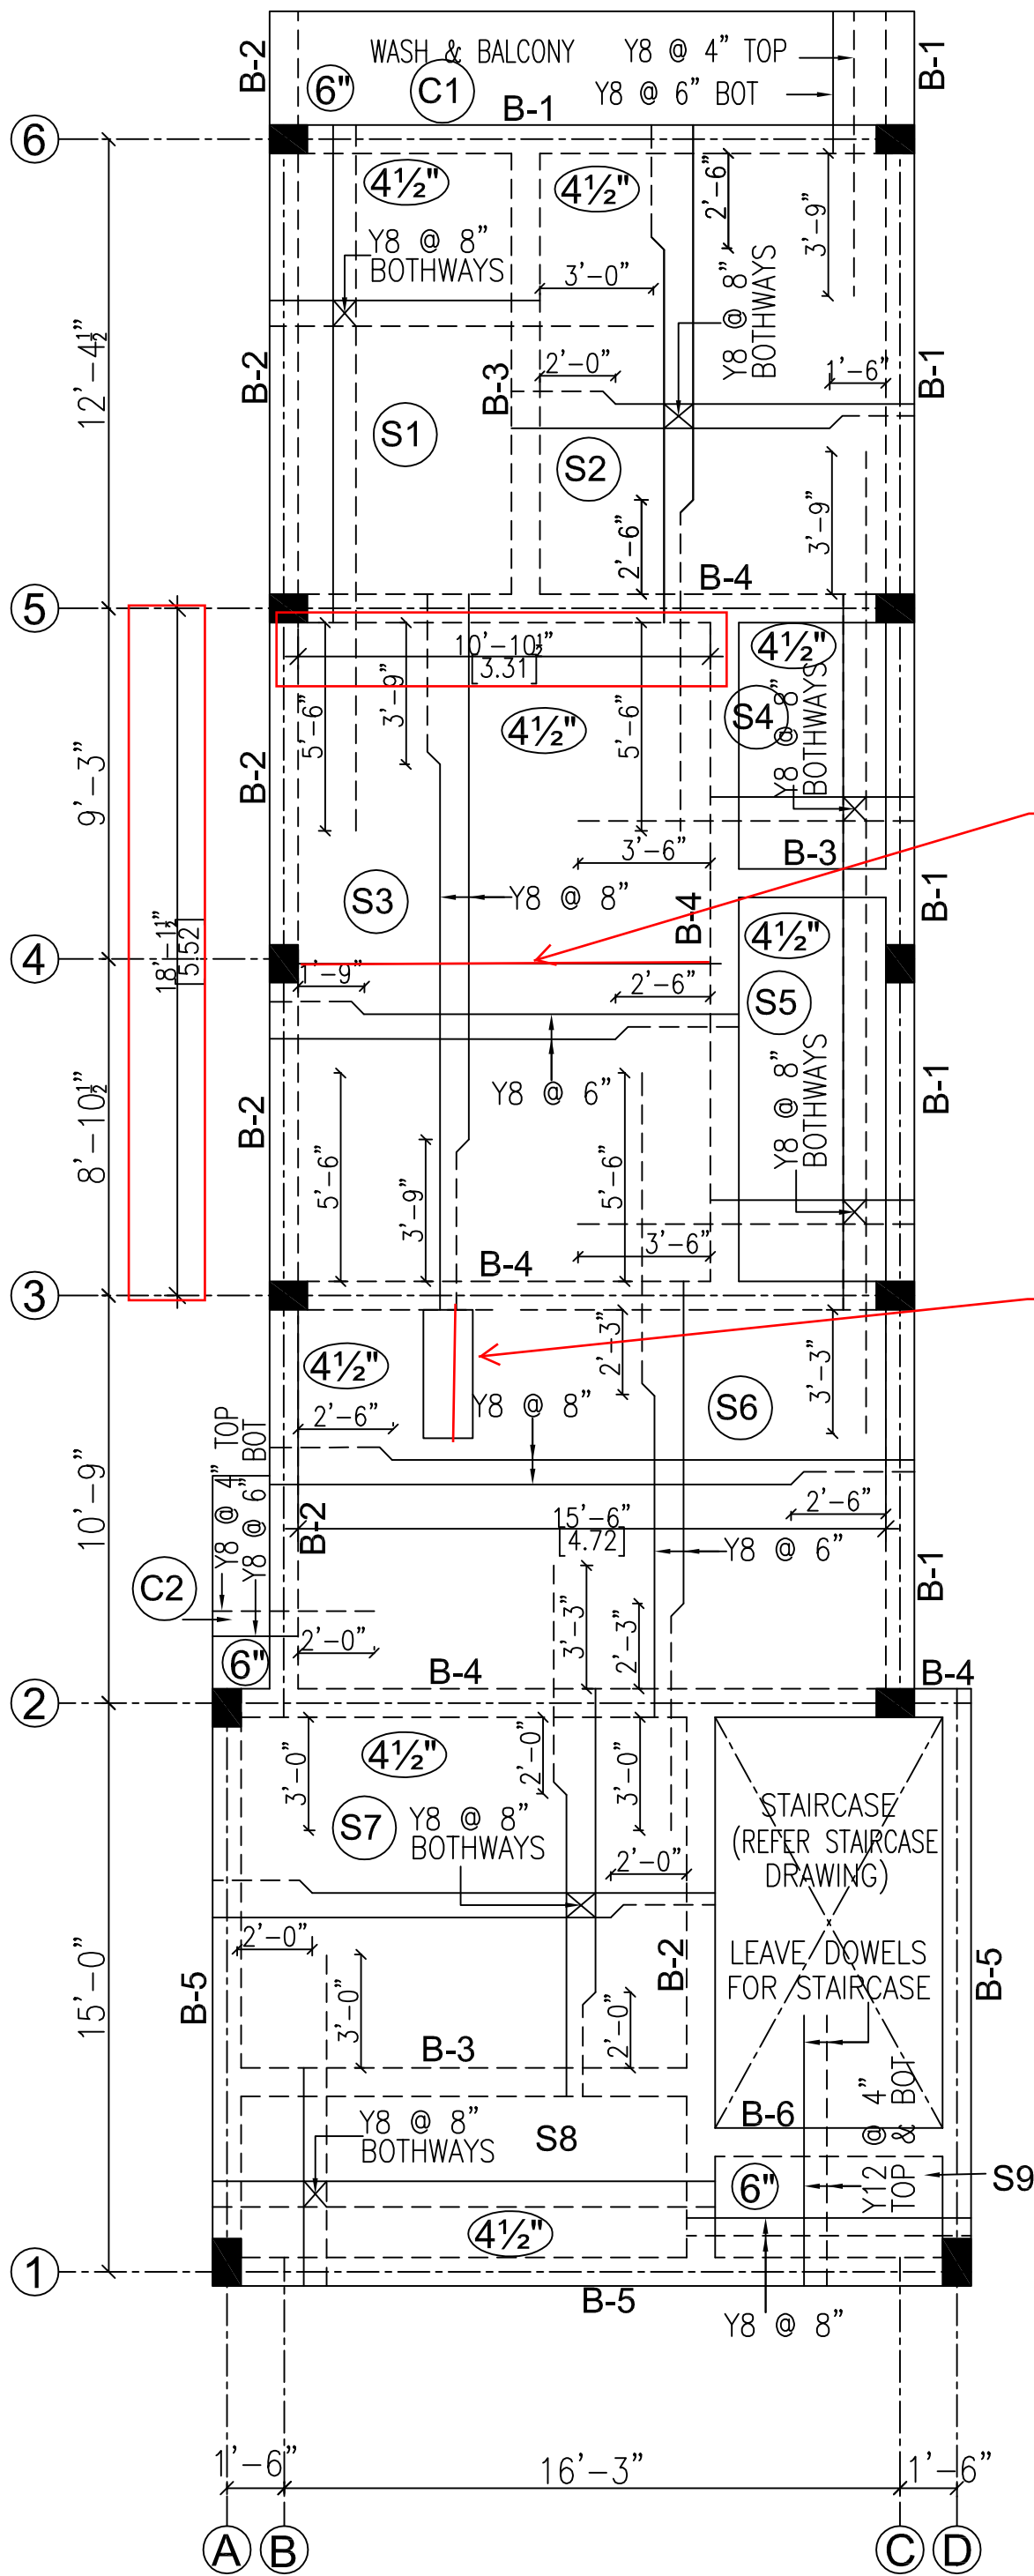
Crack penetrating full depth of slab and water seeps and drops on the occupants

We missed the 0.3 l extension of the slab and the owner after consulting other consultant blames this is the reason for crack in slab
